Collector(s): Estuarine Monitoring Team (WaRO)

Locations and Date: Dances Bay on Little River, 7/2/2019

Reason Collected: Discolored water/suspected bloom

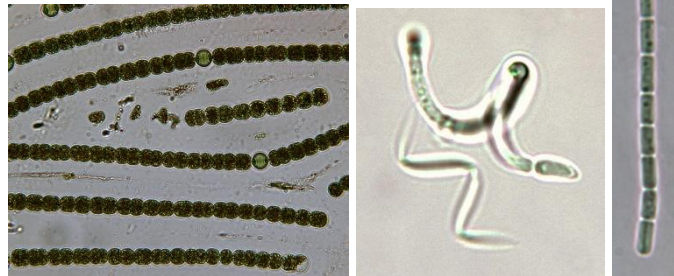
Figures 3, 4, 5: *Dolichospermum*, *Cylindrospermopsis*, *Pseudanabaena*

Results of Analysis: This was a bloom of filamentous cyanobacteria including *Dolichospermum*, *Cylindrospermopsis*, and *Pseudanabaena* (Figures 3-5).
